THE ERUPTION IMPACTS TO THE SPRINGS OF MT. MERAPI

T. Listyani R.A.

Geological Department, College of Technology STTNAS Yogyakarta

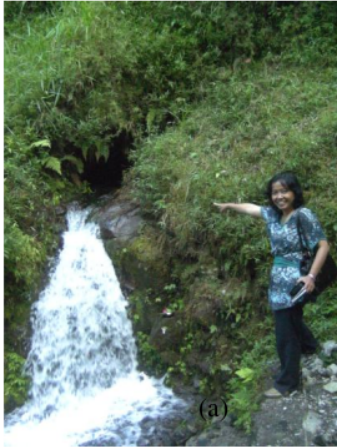
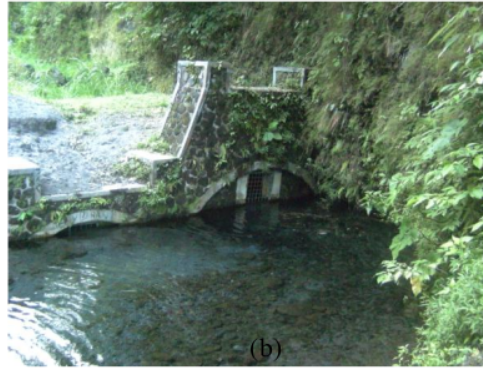
Figure 3. Upstream of Kuning River has many springs, the high discharge of them are Umbul Lanang (a) dan Umbul Wadon (b). Photograph was taken before eruption.

Until Sunday, 12th of December, 2010, as Estily (2010) and also TvOne (Anonim, 2010b) said, Umbul Wadon and Umbul Lanang still safe although almost all of drainage pipes have been broken by eruption materials. The two springs themselves didn't buried by laharic materials. These springs provide water supply for people of Sleman Regency and Yogyakarta City, in addition to the agricultural irrigation at northern part Sleman. Fortunately, the water discharge discharged by Umbul Lanang even increase from 15 l/s before eruption up to 400 l/s, while Umbul Wadon buried

slightly by Merapi materials, its discharge become reduced. Before eruption, water discharge of Umbul Wadon reached 350 to 400 l/s (Chair of Sleman Energy & Mineral Resource Agency *vide* Estily, 2010).

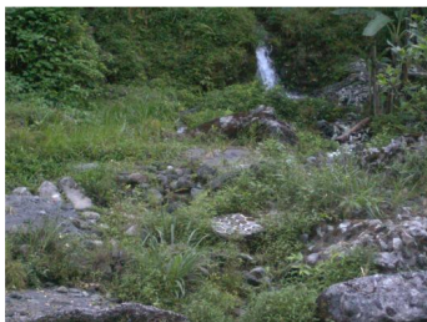
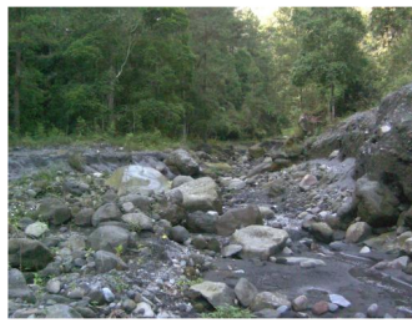
Joewono (2010) on October 28th, 2010 revealed that Mt. Merapi explotion didn't deteriorate Umbul Wadon spring which is menyebutkan bahwa letusan Gunung Merapi tidak sampai merusak mata air Umbul Wadon, which became mainstay for residents of Merapi sloping area and also Regional Water Company of Sleman District for supplying raw water. Umbul Wadon spring at the base

of Kuning River (Figure 4) didn't get any problem in its discharge as well as quality. The water usually distributes to Pakem, Ngemplak, Sleman, Mlati, Depok and Kalasan Sub Districts. Nevertheless, most refugees of Hargobinangun Village have difficulty in clean water supply because of volcanic ash polution in river or springs.

Figure 4. Landform of Kuning River at southern slope of Merapi. There is several springs appear along the river, even in high discharge such as Umbul Wadon and Umbul Lanang.

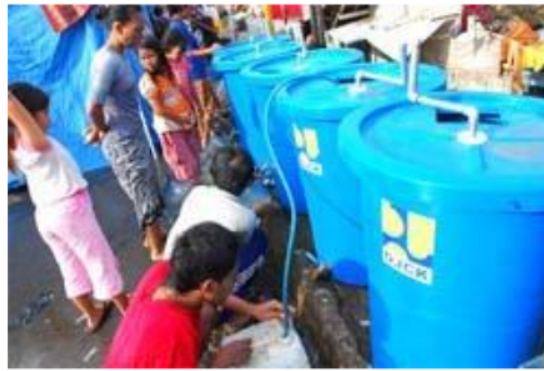
In order to get clean water, the people at Umbulharjo used water stored in drums as governmental subsidy (Figure 5). Actually, this water provided by Indonesia Red Cross has been insufficient yet, so the people must take the water from the springs. However, JPNN (Anonim, 2010d) reported on 22nd of December, 2010 that water pipes at Kuning River were broke.

Figure 5. The people at Umbulharjo, flocked to take clean water after stored in water tanks.

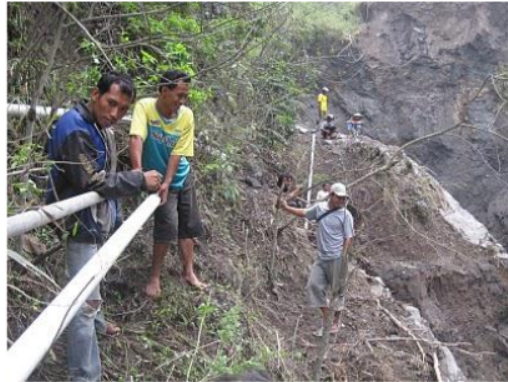
The 2010 Merapi eruption left less amused thing for citizens of Turgo area (small country at Purwobinangun Village, Pakem Sub District, caused water drainage were broken apart stricken by cold lahar of Boyong River. The spring at

this area, namely Candi Spring, difficult to reach because it is located at steep slope, about 5 km from Merapi summit (Budiharto, 2011). This spring drain the water after the people worked together to repaired the pipelines (Figure 6).

Figure 6. People at Turgo worked together to improve pipelines from Candi Spring (Budiharto, 2011).

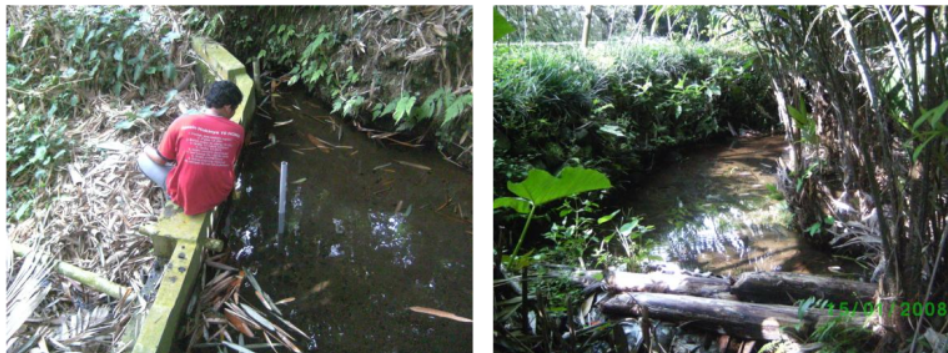
Turi region has several springs whose discharge generally small to medium. One of them can be found at Mangungsari (Figure 7). At this small country, at least there are two springs support residents life. These springs

appear from massive, clastic volcanic andesite breccia, with pebble to cobble fragments, and coarse sandy to clayey matrix. The top of aquifer layers have measured permeability as high as $1,69 \cdot 10^{-2}$ cm/s (Listyani, 2010).

Figure 7. Several springs appear from volcanic breccia aquifer at Turi, Sleman (picture is taken before eruption).

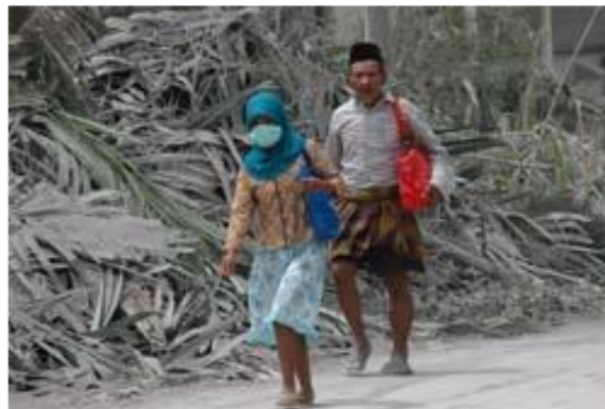
Dukun, dan Sawangan Sub Districts (Magelang District) had experience in water shortage because the installation of water pipelines damaged caused by hitting of cold laharic flood or mud clogging. Several springs even do not produce water any more because of volcanic materials burial. The laharic materials also clogged irrigation channels, make difficulty in cultivation. Water pipeline passing through the river drifted due to hitting of cold lava flood effected the clean water supply to homes totally stopped. Some residents were forced to take water on foot so far (Figure 8).

Figure 8. People of Tontro got difficulty for gaining clean water. They must go on foot as far as 1 – 2 km to reach the spring (Anonim, 2011).
