Rapid Visual Screening of Building for Potential Ground Movement in Kalirejo, Kulonprogo, Yogyakarta

4
Rapid Visual Screening of Building for Potential Ground Movement in Kalirejo, Kulonprogo, Yogyakarta

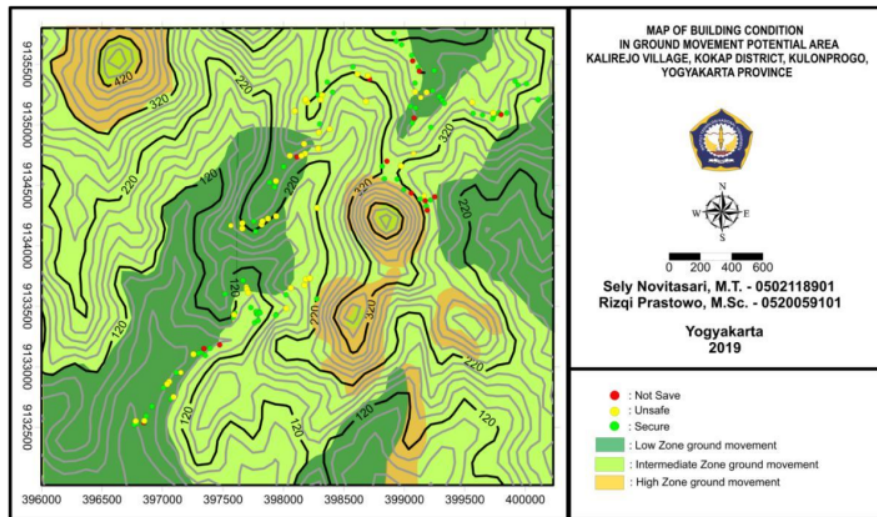
Figure 3. Map of Building Condition of Sample Site at Kokap District, Yogyakarta, Indonesia

The results of the calculation of the building score (Table 2) obtained the value of the condition of the entire building that has been surveyed. In table 2 is a recapitulation of building score results (and the coordinates of his home field) from the evaluation of

simple buildings in the four hamlets in the Kalirejo area. Building conditions are obtained by following the conditions index scale according to table 1 and giving color to each building category. Green color for safe building conditions with building conditions

index value is 70-100%, yellow for unsafe building conditions with building condition index values 40-69%, and red for unsafe

building conditions with building condition index values 0-39 % building classification in the form of color can be seen in figure 3.
