[JESTEC] Undercutting Mining

UNDERCUTTING MINING METHOD, WHY NOT? A GEOTECHNICAL CONSIDERATION FOR COAL OPTIMIZATION

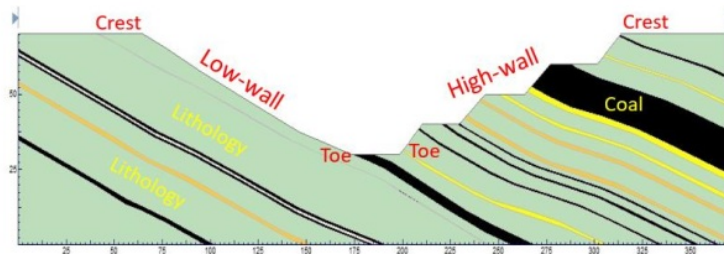
Fig. 1. Low-wall and high-wall of coal open-pit mine [1].

Coal deposits, especially in back-arc basin and fore-arc basin, usually form successive layers with specific bedding position. The dip of coal bedding varies from gently sloping to perpendicular forming a vertical bedding. In several locations of the study area, folding structures were found in either micro or macro scales. Based on the geological condition, mining activity will form high-wall and low-wall sections. High-wall is part of mine slope that is perpendicular to the dip of rock bedding, while low-wall is the dip of mine slope that is in the same direction as the dip of rock bedding (Fig. 1). Undercutting mining is defined as mining activity that cuts low-wall slope so that the angle of mine slope is greater than the angle of rock bedding or discontinuous plane (daylight).

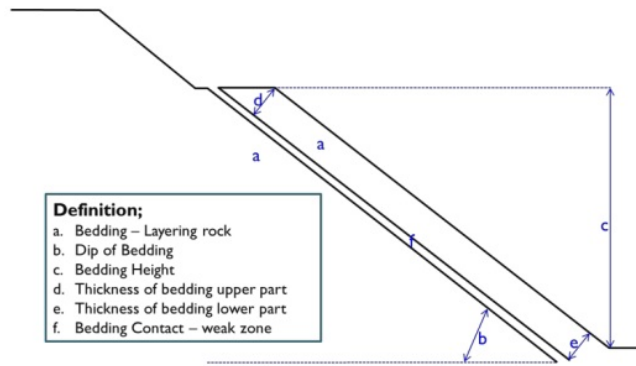
Fig. 2. Bedding ratio at low-wall [1].

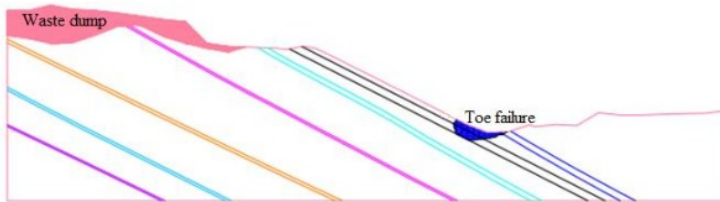
Fig. 3. Landslide at low-wall due to toe failure [3].

Contact between beds is a weak zone, and at the contact of rock bedding, it is usually found a thin layer that can trigger instability of slope. Slope stability of low-wall is affected by bedding contact between two rocks [2]. Bedding contact is usually in the form of clay which has high plasticity, thus it will separate two different beds. Because it separates two different parts, the cohesion value becomes zero and the internal friction angle becomes 13° , which were obtained based on back analysis result [2]. When a weak plane is formed at contact of two rocks, it is assumed that the upper bed only relies on the bed below it, so, with the concept of stress, the smaller the lower part, the greater the stress received, leading to potential for overstress at the toe. Overstress occurs due to difference in bedding ratio between the top and the bottom. The smaller the bedding ratio, the smaller the safety factor produced (Fig. 2) [1]. Since the rock bedding has a weak zone, it may cause failure at the toe. The toe failure is one of the contributing factors that leads to landslide at low-wall (Fig. 3) [3].

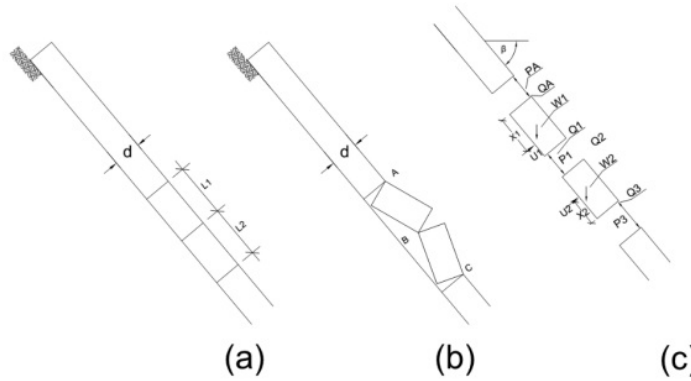
Fig. 4. Inaccurate application of rigid-and-jointed bed for low-wall stability [4].

Slope stability analysis is closely related to the existing structure pattern, especially discontinuous plane. In this analysis, rock was assumed to be a rigid plane separated by weak plane that is cut by joints making the bed look like being cut into pieces; thus, the movement is purely due to frictional force at the bottom of the slope. When driving force gets bigger, buckling will potentially occur (Fig. 4).

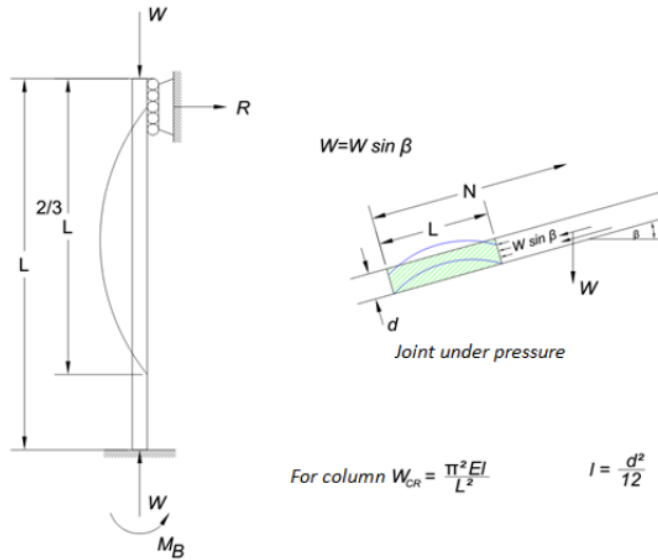
Fig. 5. Buckling concept at low-wall [4].

Analysis of landslide **due to** buckling is carried out with assumption that at the toe of slope there are joints receiving pressure along the slope, and additional assumption of Young's modulus (Fig. 5). As a result of the pressure, buckling occurs. The shorter buckling (L), the greater the force required for the buckling process to occur. Water flowing in sandstone pore and impermeable mudstone cause a decrease in values of cohesion and internal friction angle.

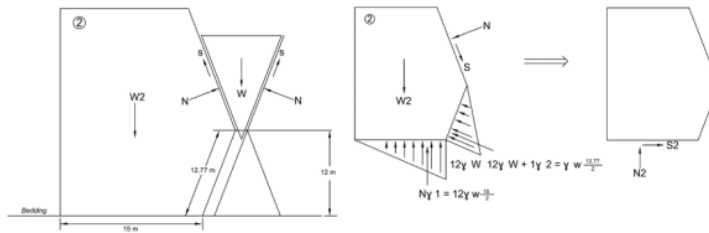
Fig. 6. Unfavorable joint mechanism [4].

Joint pattern plays a very important role **for instability** because there are some joints that are key to all joint systems. This type of instability is triggered by joint or fracture that cuts each other forming a shape of "X". Under normal condition, instability of natural slope is generally in stable condition. However, if a part of the "X" formation is taken due to slope forming, then instability may occur due to

reduced horizontal force and increased groundwater level in joint area that results in increased hydrostatic pressure either vertically or horizontally (Fig. 6). Instability will occur when resisting force is smaller than driving force. If this mechanism can be known from the beginning, then instability can be anticipated early.

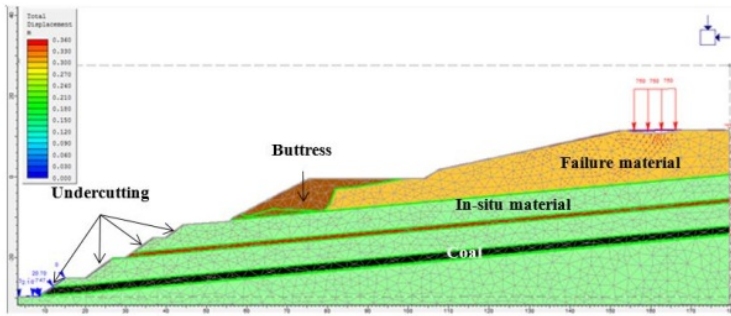
Fig. 7. Distribution of in-situ and failure materials.

The stratigraphic unit of research area in the form of landslide material was on slope surface with a dip of about 14° and a material thickness of about 30 m. In-situ materials were beddings of claystone, mudstone, and coal with dips of about 7-9°. Counterweight was put on the toe of landslide material by back filling up the overburden material layer by layer, so that optimal buttress was obtained. Undercutting was carried out about 15 m from the buttress toe with an undercut depth of about 35 m, calculated from the elevation of buttress toe. The dip of undercutting slope was about 38°, therefore there was daylight due to the bedding dip of 9° (Fig. 7).

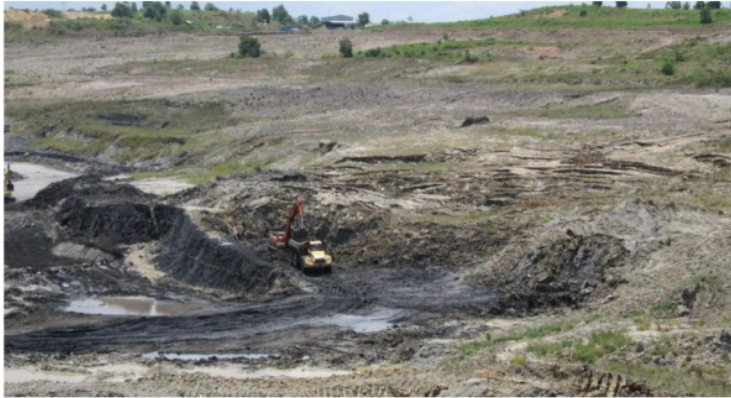
Fig. 8. Excavation using box cut method at low-wall.

Soft material at the toe of landslide material had been cleaned before the buttress construction. Removal of the landslide toe caused creeping on 1/3 part of the slope (after being submerged) but did not cause major failure (Fig. 8). Counterweight was formed at the toe of slope with a height of 15 m and a width of 25 m, and buttress dip of 17°. Undercutting formed a slope by cutting the bedding plane of in-situ rock on the low-wall side, causing daylight. Slope formation in the undercutting position was adjusted to the overall slope for undercutting.

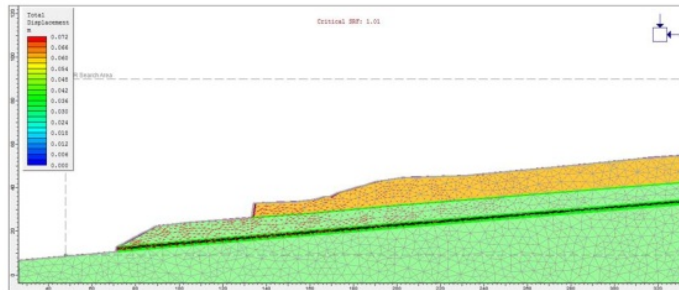
Fig. 9. Single step of in-situ and failure materials without buttress.

The analysis shows that the landslide material had safety factor of 1.01 which indicated repose condition, and this was in accordance with the real condition where the slope dip of landslide material was formed naturally when landslide occurred (Fig. 9). Stress accumulation was found at the toe of slope with slip surface in the contact area between the in-situ material and the landslide material above it. This was in line with the characteristics of the location. Buttress construction increased the stability of landslide material to 1.08, but when undercutting was carried out, the slope stability changed to 1.03 (Figs. 10 and 11).

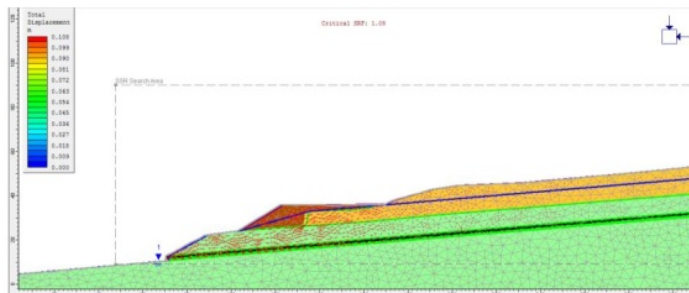
Fig. 10. Single step of in-situ and failure materials with buttress showing groundwater level to buttress.

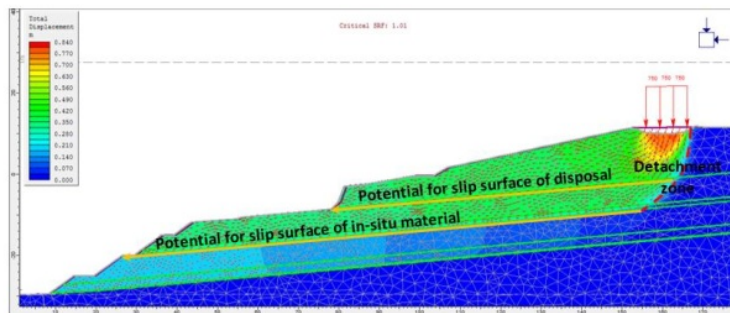
Fig. 12. Distribution of total displacement showing semi-circular pattern.

Potential for landslide was found in the landslide material and in the discontinuous plane along the rock bedding which was a weak zone that controlled instability (Fig. 12). Material deformation occurred more in the landslide material and in the upper in-situ bed. Undercutting mining can be carried out with strict control to maintain the material properties at the top and in the in-situ material. The safety factor of 1.03 is a critical number, therefore, this should be utilized in undercutting mining. Surface water must also be managed to avoid either surface water flow into the landslide zone or infiltration to the contact zone between the in-situ and the landslide materials. If water gets into the contact zone, it will trigger slip surface along the contact zone. Heavy equipment in the landslide zone must also be restricted to keep the load stable. Heavy equipment activity in the landslide area can increase the material load, so the driving force becomes greater.

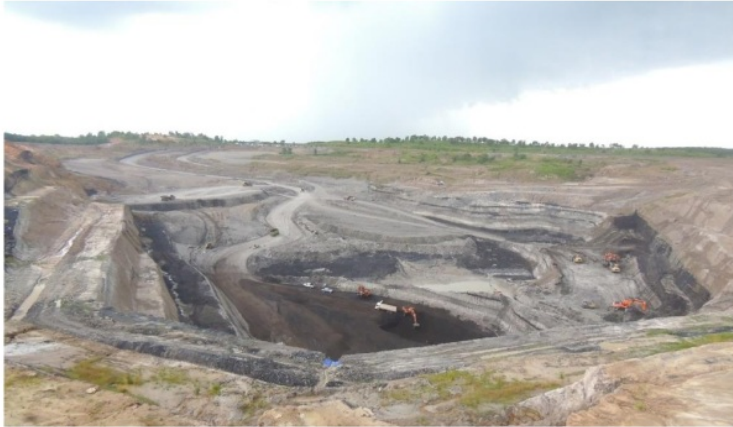
Fig. 13. Mining was completed using undercutting method without any instability issue.

Slope monitoring system is also mandatory to obtain real condition of slope stability. The monitoring can use simple tool, considering the material has a high plasticity, so that the potential for sudden failure is quite small. Visual observation on drainage condition and buttress stability should also be regularly carried out during undercutting. With strict control, undercutting can be carried out safely and coal can be mined out properly. Coal reserves increased significantly based on the result of this analysis. When the mining is completed, the stability of undercutting and buttress were maintained (Fig. 13).
