THE ERUPTION IMPACTS TO THE SPRINGS OF MT. MERAPI

T. Listyani R.A.

ABSTRACT

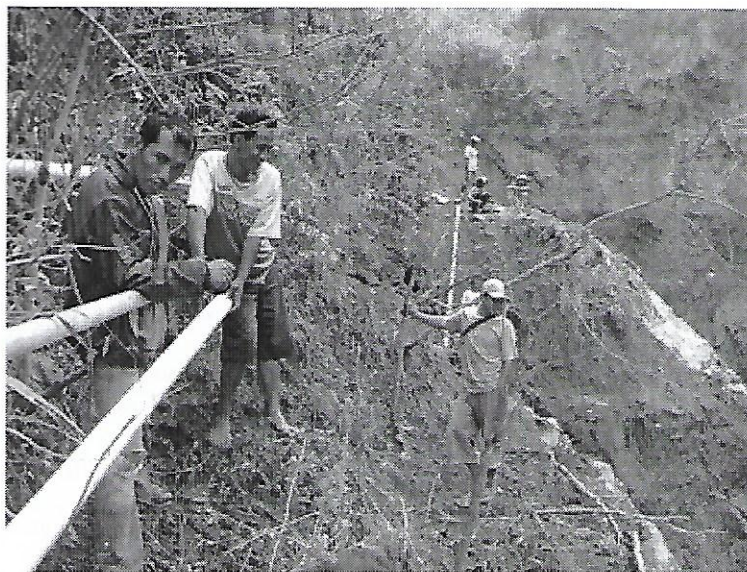
Figure 6. People at Turgo worked together to improve pipelines from Candi Spring (Budiharto, 2011).

namely Candi Spring, difficult to reach because it is located at steep slope, about 5 km from Merapi summit (Budiharto, 2011). This spring drain the water after the people worked together to repaired the pipelines (Figure 6).

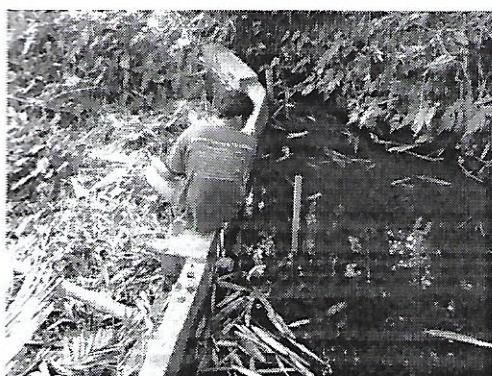
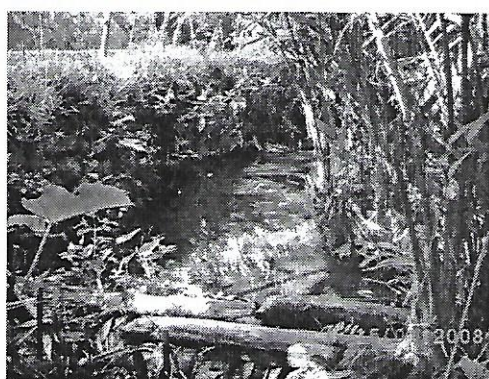
Figure 7. Several springs appear from volcanic breccia aquifer at Turi, Sleman (picture is taken before eruption).

Turi region has several springs whose discharge generally small to medium. One of them can be found at Manggungsari (Figure 7). At this small country, at least there are two springs support residents life.

These springs appear from massive, clastic volcanic andesite breccia, with pebble to cobble fragments, and coarse sandy to clayey matrix. The top of aquifer layers have measured permeability as high as $1,69.10^{-2}$ cm/s (Listyani, 2010).
