# IDENTIFICATION OF SLIP SURFACES USING THE GEOELECTRIC IMAGING METHOD IN THE KALIREJO AREA, KOKAP DISTRICT, YOGYAKARTA, INDONESIA

Rizqi Prastowo<sup>1</sup>, Hurien Helmi<sup>2</sup>, Obrin Trianda<sup>3</sup>, Rofiqul Umam<sup>4</sup>  
Institut Teknologi Nasional Yogyakarta, Indonesia<sup>1,2,3</sup>, Kwansai Gakuin University, Japan<sup>4</sup>  
rizqi@itny.ac.id<sup>1</sup>, hurien.helmi@itny.ac.id<sup>2</sup>, obrin@itny.ac.id<sup>3</sup>, egk71822@kwansai.ac.jp<sup>4</sup>

Landslide; Slip Surface;  
Resistivity; Kokap

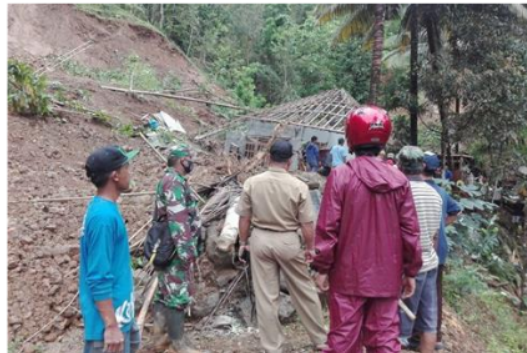
**Fig 1.** The landslide was damaged a house near Kalirejo Village

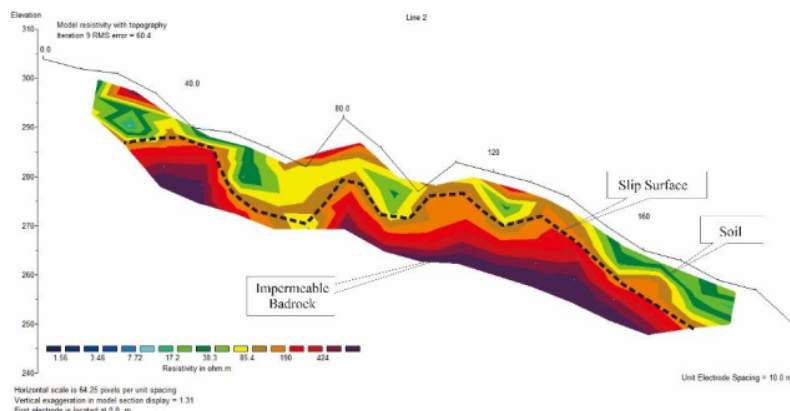
Resistivity Survey Line 2 shows that the slip plane is at a distance of 86 m from the starting point and in the derivative area from an elevation of 280 m to 260 m (Fig. 6). The slip plane is at a depth of about 10 m. The slip plane is in the form of igneous rock, namely andesite, shown in red with a resistivity between 424  $\Omega\text{m}$  shown on the dashed black line. The resistivity value of 50-190  $\Omega\text{m}$  is the soil marked with a green-orange colour. In contrast, the resistivity of 1.56-30  $\Omega\text{m}$  is soil with water saturation.

8  
**Fig 6.** Section of 2D Geoelectric on Resistivity Survey Line 2

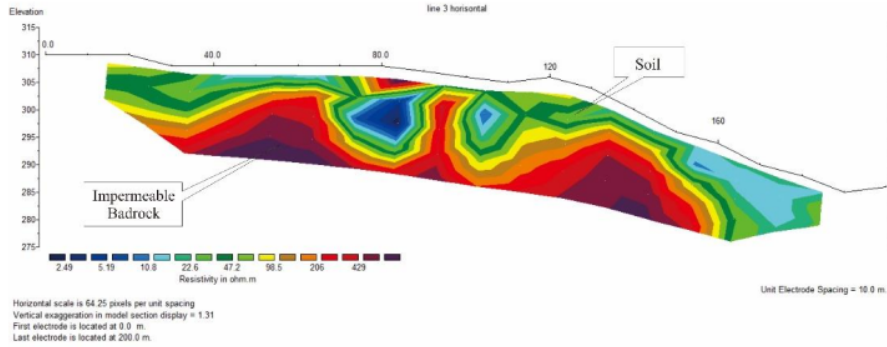
Resistivity Survey Line 3 is a horizontal path used to see horizontal resistivity continuity (Fig. 7). Igneous rock is andesite shown in red, with a resistivity between 429  $\Omega\text{m}$  shown in red. The resistivity value of 30-206  $\Omega\text{m}$  is the soil marked with a green-orange colour. In contrast, the resistivity 2.49-15  $\Omega\text{m}$  is the soil with water pasteurization, indicated by the colour dark blue - light blue.

**7**  
**Fig 7. Section of 2D Geoelectric on Resistivity Survey Line 3**

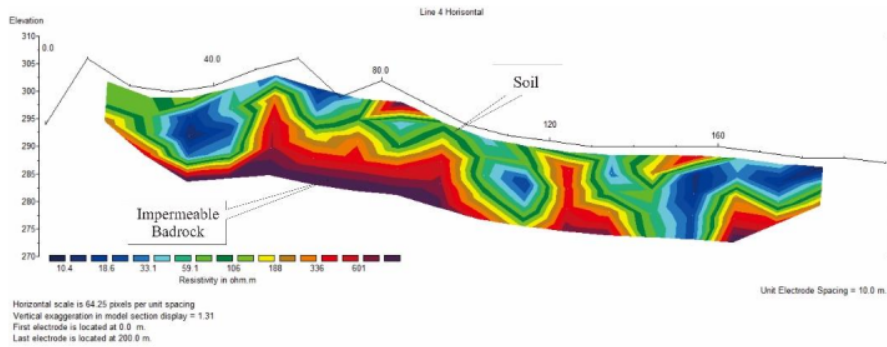
Resistivity Survey Line 4 is also a horizontal path used to see the continuity of horizontal resistivity. Igneous rock is andesite shown in red with a resistivity between 400-700  $\Omega\text{m}$  shown in pink-red. The resistivity value of 59-200  $\Omega\text{m}$  is the soil marked with a green-orange colour. In contrast, the resistivity of 10.4-35  $\Omega\text{m}$  is the soil with water pasteurization, indicated by dark blue - light blue colour.

**7**  
**Fig 8. Section of 2D Geoelectric on Resistivity Survey Line 4**
