# Geoelectrical resistivity survey to determine sliding surface of landslides prone area case study in Ponjong subdistrict Gunung Kidul regency Indonesia

Al Hussein Flowers Rizqi<sup>\*1</sup>, Oky Sugarbo<sup>2</sup>, Mayang Pitaloka<sup>3</sup>  
1,2,3 Department of Geological Engineering, Institut Teknologi Nasional Yogyakarta

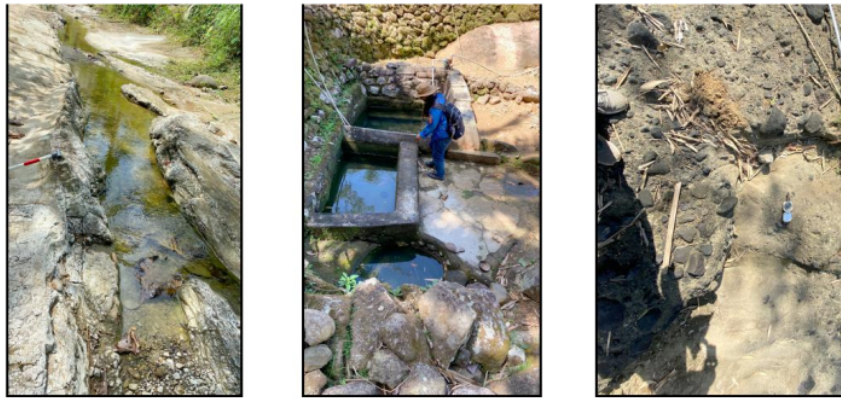
Figure 4. The gauge in Krenceng river, Tambakromo, Ponjong (left). The springs in Grogol village, indicated the structural geology (center). The offset of rock layer (tuffaceous lapillistone and andesitic breccia (right)

Structural geology data was analyzed in stereography analysis with Dips 6 Software. The fault planes, gauge, lineaments, slicken side, and offset of rock layers are structural geology data that supported the fault analysis (Figure 4). The faults data were processed to get the main fault and name of faults based on [17]. There were 5 faults in research area that included in strike slip fault (Table 1).
