## **Goelectrical Resistivity Survey To Determine Sliding Surface of Landslides Prone Area – Case Study in Ponjong Subdistrict, Gunung Kidul Regency, Indonesia**

**Al Hussein Flowers Rizqi<sup>1</sup>, Oky Sugarbo<sup>1</sup>, Mayang Pitaloka<sup>1</sup>**

<sup>1</sup>Department of Geological Engineering, Institut Teknologi Nasional Yogyakarta  
Email: alhussein@sttnas.ac.id

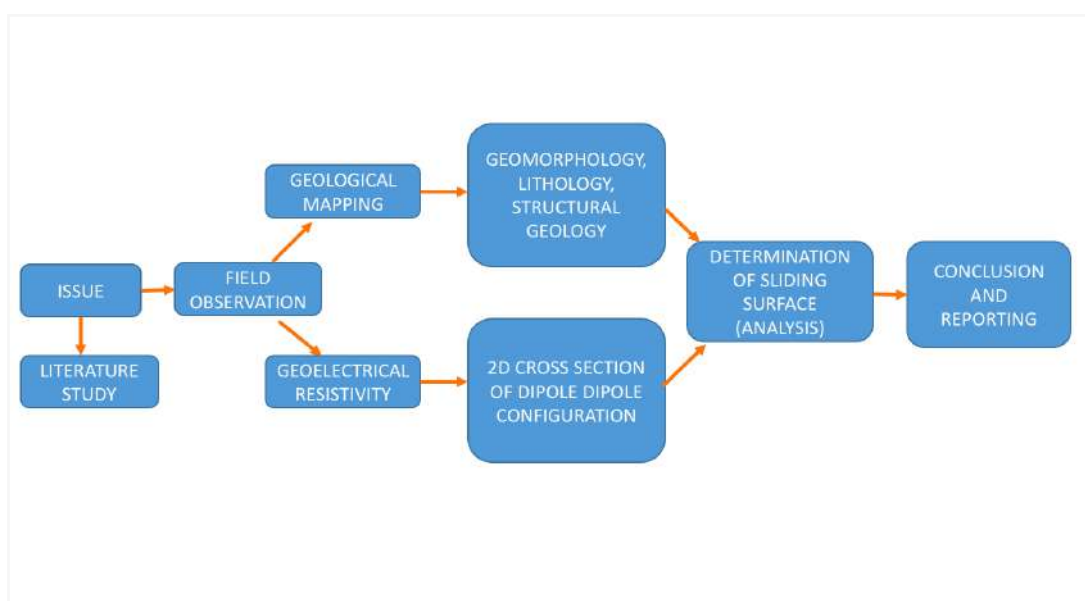
Figure 1. Flow Chart of Research Method

This research is started with study of literature about the geological condition in the research area (Figure 1). Geomorphology, lithology, and structural geology of this research area were studied by some authors. The research area is consisted of karst topography [10] and dominated by Mandalika Formation, Semilir Formation, and Wonosari Formation [11].

Field observation was conducted to the geological mapping and geoelectrical resistivity. The result of geological mapping would produced the geological map. Geological map showed that the factors that caused the landslide included in slope, lithology, structural geology, and land use.

The geophysics included in geoelectrical survey. The geoelectrical resistivity survey measured the rock resistivity in 2 studies site with dipole-dipole configuration. The result is 2 D resistivity cross section which showed that the subsurface condition in research area. The sliding surface is interpreted by rock resistivity value that has a small resistivity value and included in claystone [12].

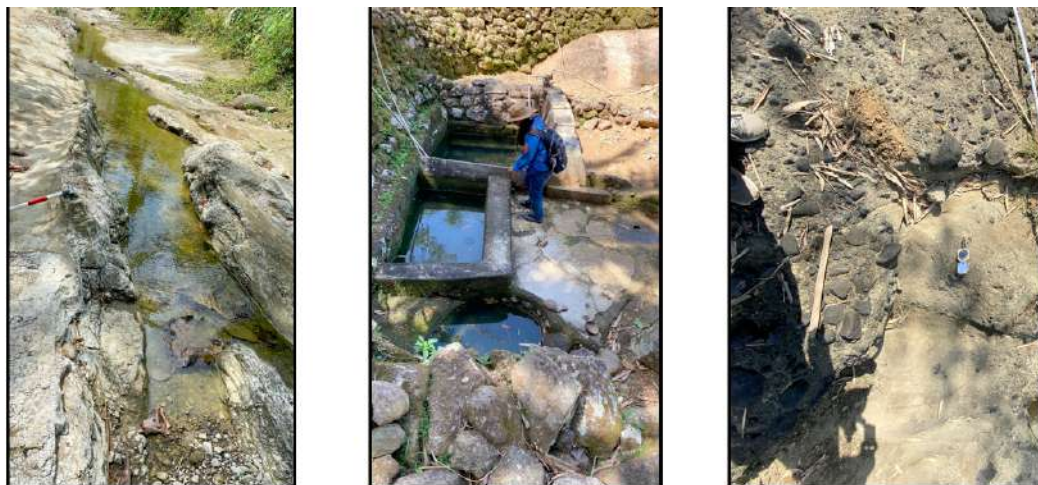
Figure 4. The gauge in Krenceng river, Tambakromo, Ponjong (left). The springs in Grogol village, indicated the structural geology (center). The offset of rock layer (tuffaceous lapillistone and andesitic breccia (right)

Structural geology data was analyzed in stereography analysis with Dips 6 Software. The fault planes, gauge, lineaments, slicken side, and offset of rock layers are structural geology data that supported the fault analysis (**Figure 4**). The faults data were processed to get the main fault and name of faults based on [17]. There were 5 faults in research area that included in strike slip fault (Table 1).

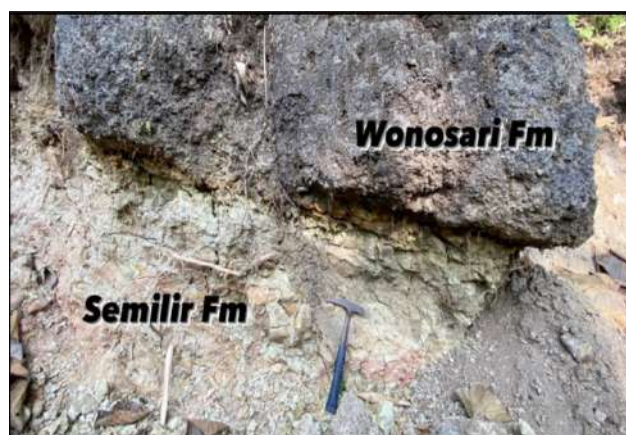
Figure 5. The rock contact formation of Semilir Formation and Wonosari Formation

The resistivity value from 29.9 to 140 ohmmeter is interpreted by tuffaceous lapillistone. Tuffaceous lapillistone is correlated to regional stratigraphy with Semilir Formation and has a rock contact with Wonosari Formation (limestone) in angular unconformity relationship (**Figure 5**). At depth of 15 to 20 metres, there is some lens of aquifer that showed in orange colour with resistivity value of 0.26 to 1.28 ohmmeter. The manifestation of surface water is presented by spring in the field.

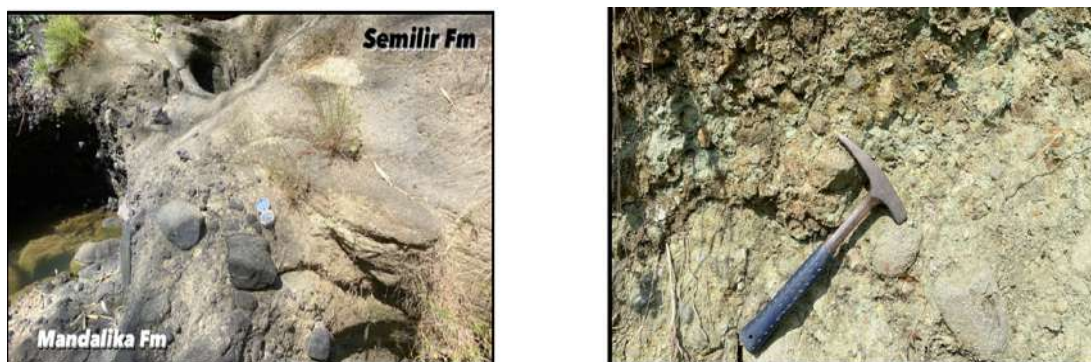
Figure 7. The rock contact formation of Mandalika Formation and Semilir Formation (left). The altered clay that derived from altered fragment and matrix of andesitic breccia (right)

The lithology in Sumberejo village is consisted of andesitic breccia, tuffaceous lapillistone, and tuffaceous claystone. The basement or the oldest rock layer is interpreted by andesitic breccia in brown colour with resistivity value of more 574 ohmmeter. Andesitic breccia included in Mandalika Formation [14]. The tuffaceous lapillistone is included in Semilir Formation with resistivity value in range of 131 to 574 ohmmeter. The rock contact Formation of Mandalika and Semilir Formation was observed in the field. The stratigraphical relationship between Mandalika andesitic breccia and Semilir tuffaceous lapillistone is interfingering (Figure 7).

The presence of aquifer is interpreted as a lens of rock with resistivity value in range of 0.36 to 29.9 ohmmeter. This aquifer is interpreted at depth of 18 to 20 metres. This aquifer location is in a depression in between two highland at east part of and west part of subsurface cross section (Figure 8). The resistivity value of 1.26 to 29.9 ohmmeter is interpreted as altered clay. This altered clay could be a sliding surface for landslide (Figure 7 – right). The kind of landslide is included in rotational landslide [18].
